Victoria walks

Road Safety for Pedestrians Who Are Blind or Have Low Vision

Site audits and survey

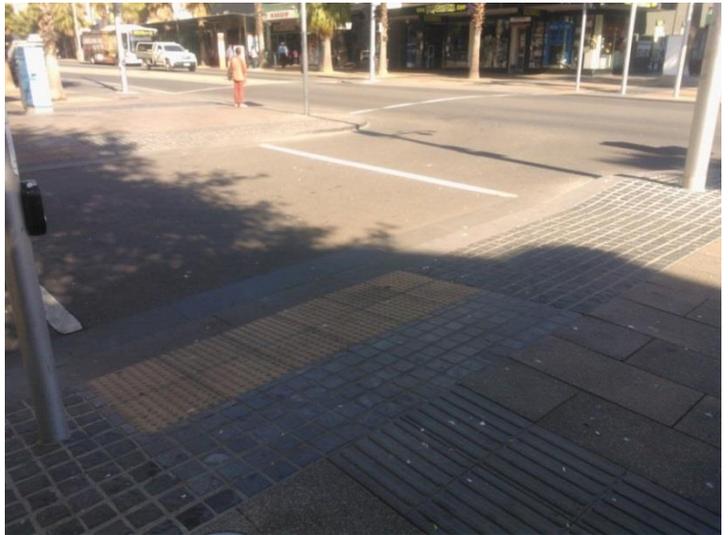
- Slow phase of audio tactiles was not audible over ambient traffic noise
- There is a gap of approx. 400mm between end of directional TGSI's and warning TGSI's
- The pedestrian lights (green/red man) on the south side are not directly visible from all areas of the kerb ramp as they face towards the intersection of Moorabool St and Little Malop St (**figure 3**)
- Difficult to distinguish contrast between footpath and road
- Directional TGSI link to building line on north side only
- The warning TGSI's do not stretch the length of the pram ramp. The pram ramp being 2.9m and the tactiles 2.4m located on the audio tactile (east) side of both the north and south crossing points (**figure 4**).
- The TGSI could be confused with the decorative tiles that surround them.

Figure 4 – TGSIs not extending across the width of the crossing and potentially confused with surrounding decorative tiles, Moorabool and Little Malop Streets

1. Ensure appropriate TGSIs are provided at entrance to Geelong Railway Station.
2. Review positioning and operation of signals and organisation of paving and TGSIs at intersection of Moorabool and Little Malop Streets.
3. Address the volume of fast phase audio tactiles to ensure they can be heard from the centre of the Ryrie St crossing (travelling north/south along Moorabool St).
4. Remodel kerb at the intersection of Moorabool and Little Ryrie Streets, to provide a more conventional configuration of kerb, kerb ramps and TGSIs; or use warning TGSIs to clearly delineate between the footpath and the road in all locations and stop cars cutting the corner.
5. Work with traders to ensure that a clear path of travel is maintained along the building line of Moorabool Street.

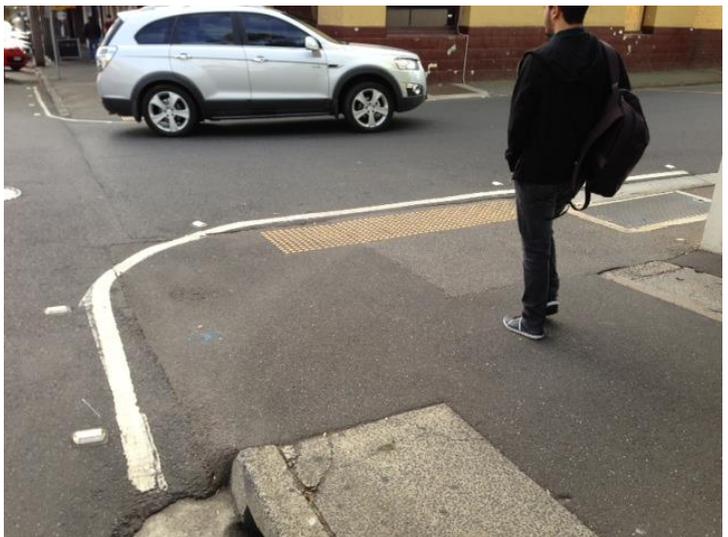
On the eastern side of Moorabool Street at Little Ryrie Street (**point 3** and **figure 5**), the footpath blends into the road, with no distinct kerb. A white line is used to define the edge of the road and TGSIs are provided in one crossing direction, but it is possible for someone with a vision impairment to miss the TGSIs and deviate into the road. This is particularly true of someone approaching along Little Ryrie Street. TGSIs are placed too close to the border of the road and kerb. In one case they are half on, half off the kerb edge. The absence of a kerb also potentially enables cars to cut across the notional footpath.

Figure 5 – footpath blending into the road, Little Ryrie Street

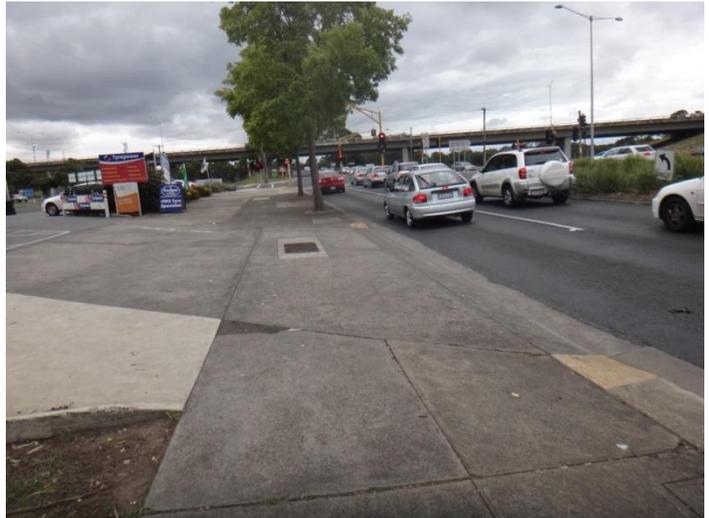
Figure 6 – entrance to Tyrepower on High St, looking north to intersection with Barwon Heads Rd and Barrabool Rd

The vehicle accessway from High Street to Tyrepower is designed to facilitate vehicle access at speed. This presents a potential hazard for pedestrians, especially those who have a vision impairment. At this point also the edge between the footpath and the road (a 60km/h traffic lane) is poorly defined.

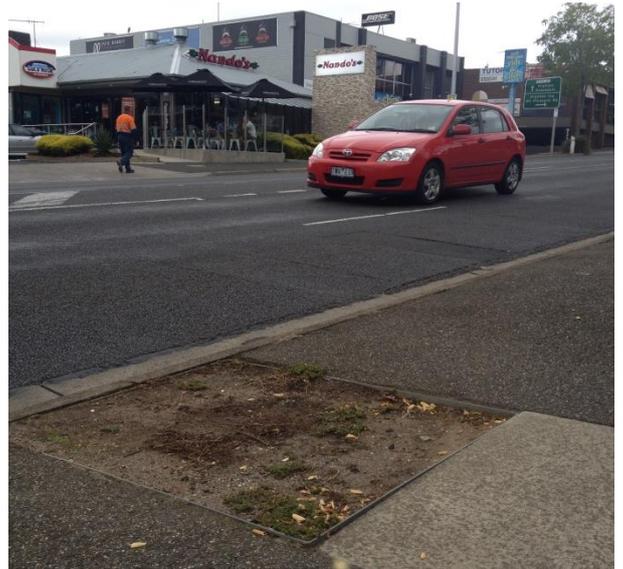
Figure 7 – trip hazard opposite Nandos

Trip hazards were identified on either side of High Street near Nandos (71 High Street, **point 4** and one example in **figure 7**). Next door, at 73 High Street, a small wall runs parallel to the footpath (**figure 8**). Painted black, this wall has little visual contrast with the footpath and could constitute a trip hazard.

1. Install raised thresholds at the High Street entrances to the K-Mart shopping centre (**point 3** on audit map).
2. Undertake a program of footpath resurfacing that crosses vehicle accessways, emphasising pedestrian priority, as part of longer term footpath asset management on High Street, between Barwon Heads Road and Roslyn Road.
3. Install TGSI at the Cameron Park bus stop on the north side of High Street (**point 2** on audit map).
4. Resurface footpath to address trip hazards on either side of High Street near Nandos (71 High Street).
5. Paint wall at 73 High Street in colours that provide a greater visual contrast with the pavement.
6. Check volume of audio tactiles at intersection of High Street and Mount Pleasant Road.
7. Upgrade infrastructure for vision impaired pedestrians (audio tactiles, TGSI, ramp alignment) at the intersection of Roslyn Road, High and Corio Streets.

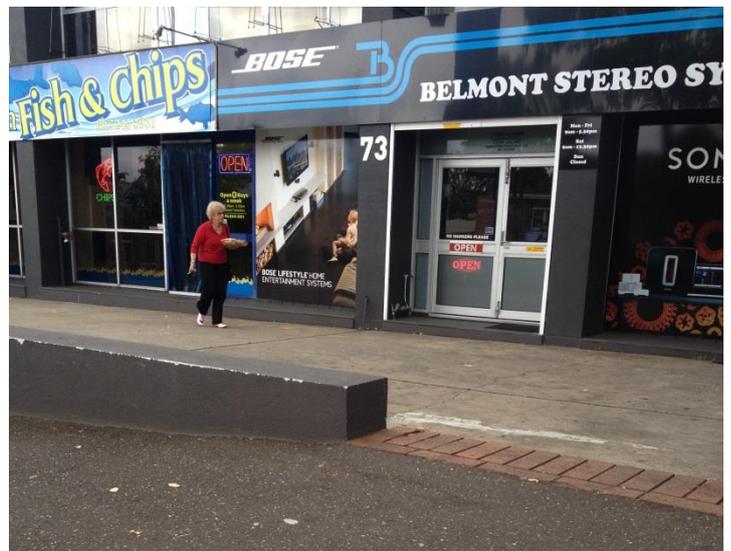
Figure 8 – wall at 73 High Street

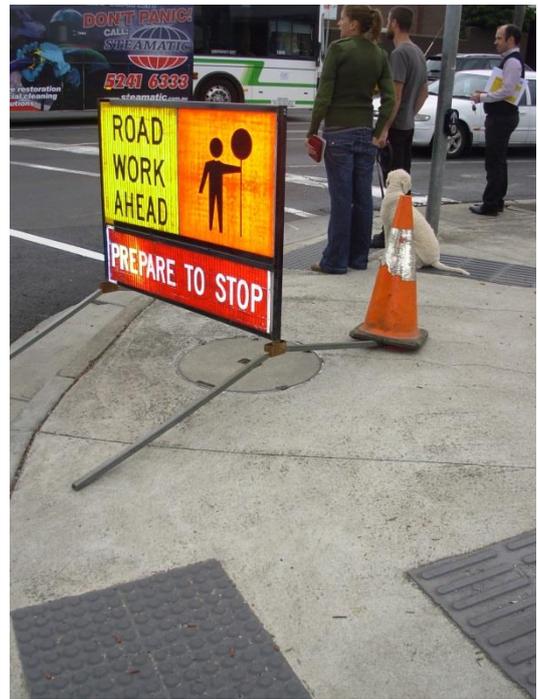
- On the east side of High Street the audio tactile is not within arm's reach for a pedestrian waiting at the ramp and TGSi were damaged.
- At the time of the audit a roadworks sign created an obstruction and a tripping hazard at one corner (**figure 9**).
- On one leg the TGSi do not align with the crossing (**figure 10**).
- Audio tactiles on two legs had only a low pulse.

Figure 9 – a poorly located construction sign presents a trip hazard at the Roslyn/High/Corio Street intersection

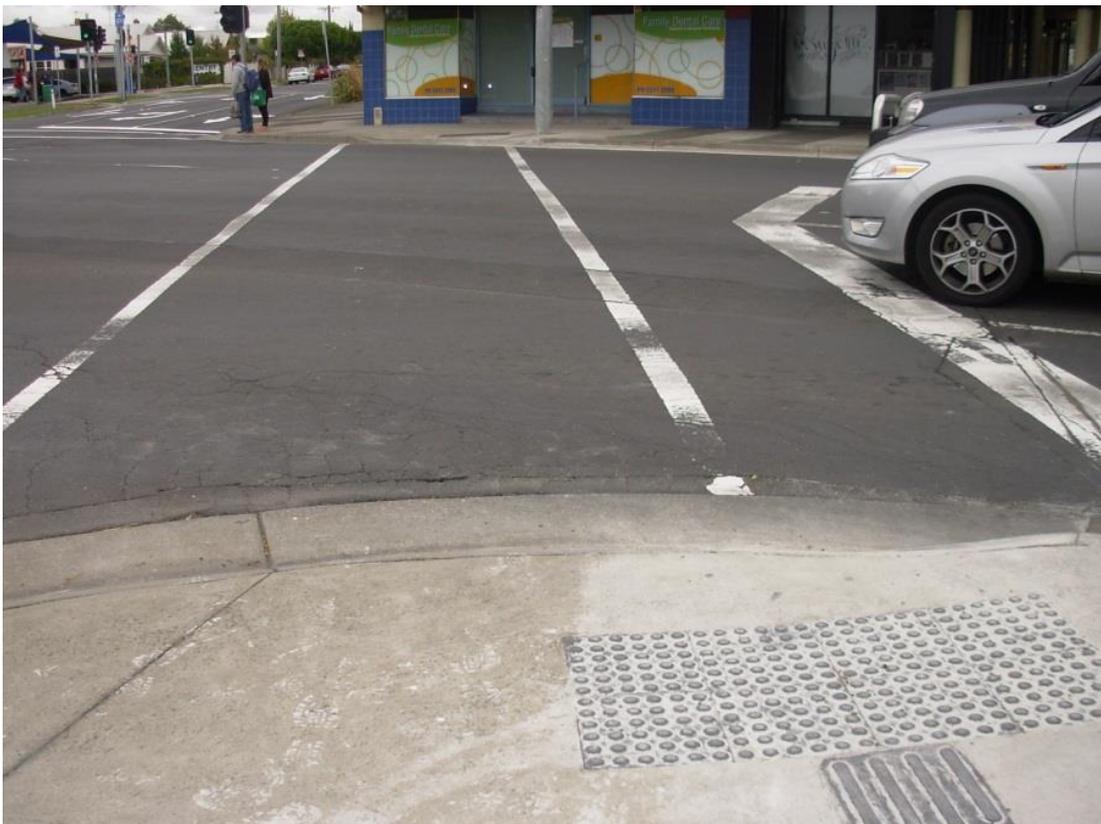
Figure 10 – poorly aligned ramps, TGSi and crossing at the Roslyn/High/Corio street intersection

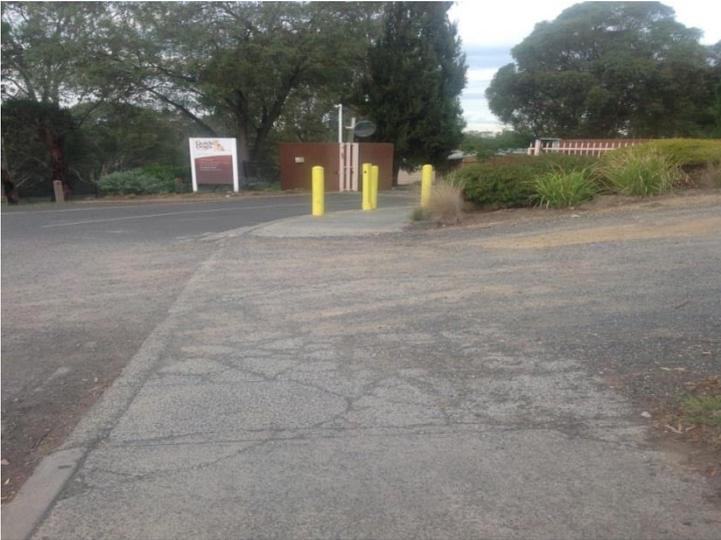
Figure 11 – maintenance track crossing footpath at entrance to GDV

At the entrance to Guide Dogs Victoria, a maintenance track running parallel to the Chandler Highway crosses the footpath (see **figure 11**). This has resulted in damage to the footpath and gravel across it, presenting a trip/slip hazard. For a pedestrian with vision impairment there is an additional risk of disorientation and confusion between the footpath and the road.

1. Reconstruct the footpath at the entrance to Guide Dogs Victoria on the Chandler Highway, Kew where it meets the maintenance track running parallel to the Highway.
2. Construct a footpath from the Chandler Highway to the bus stop on the south side of Yarra Boulevard.
3. Construct shelters at the bus stops on either side of Yarra Boulevard.
4. Co-ordinate pedestrian operated signals on the Chandler Highway near Yarra Boulevard to minimise pedestrian wait times in the central median.
5. Construct a raised pedestrian crossing across Yarra Boulevard at the intersection with Chandler Highway.
6. Alternatively, signalise the intersection of Yarra Boulevard and Chandler Highway (allowing removal of the pedestrian operated signals).

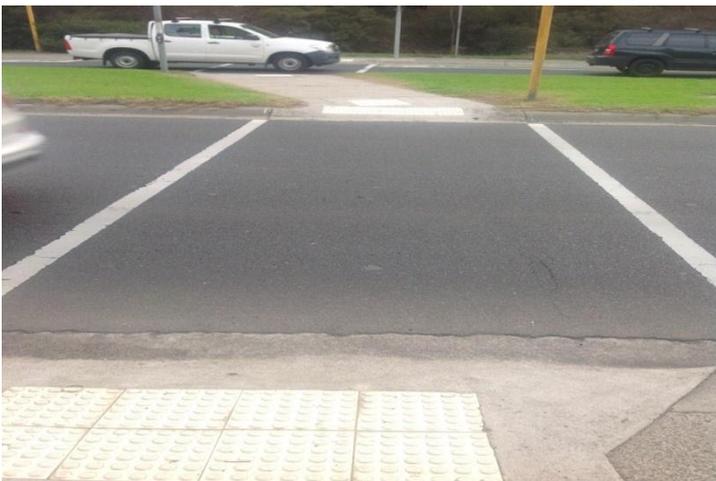
Figure 12 – pedestrian operated signals crossing Chandler Highway

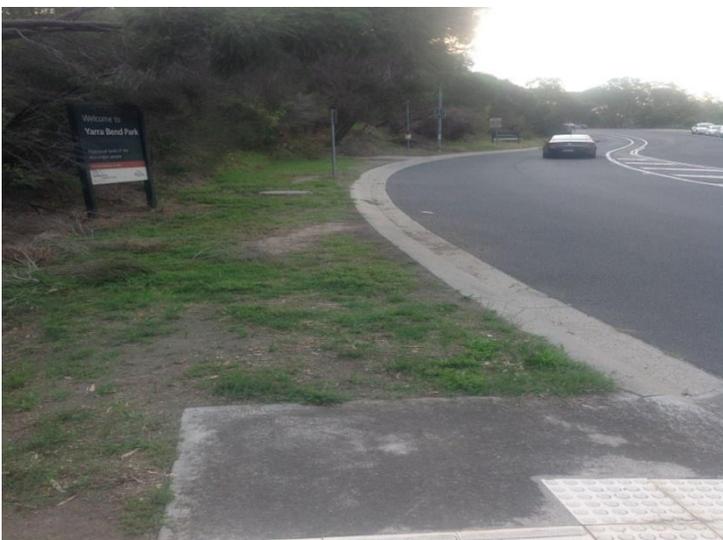
Figure 13 – south side of Yarra Boulevard looking west towards bus stop

There are bus stops on either side of Yarra Boulevard (**point 3**) immediately opposite the entrance to Guide Dogs Victoria. In other words, the bus stops are ‘across the road’ from the office. The number of problems in this very short distance is surprising.

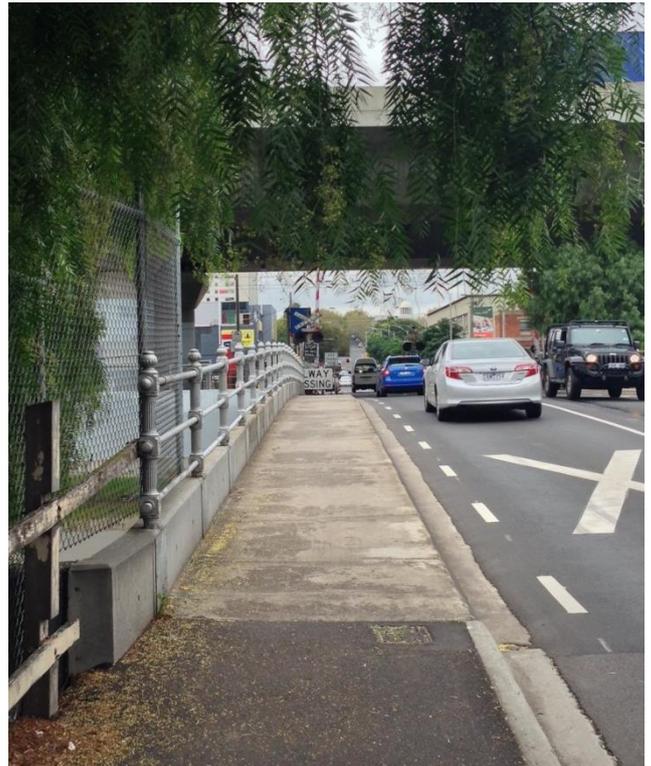
"Macaulay road going across the bridge! It's not wide enough and a fence to keep myself safe on the road side would be a lot better." (figure 14)

Figure 14 – the footpath on the north side of the Macaulay Road bridge underneath Citylink, identified as a concern by several respondents

1. Install pedestrian fencing between the footpath and the road on the north side of the Macaulay Road bridge, underneath Citylink. On the northern side of Macaulay Road between the bridge and Stubbs Street, rebuild the footpath and provide a landscaped separation between the footpath and the road.
2. Reconstruct the north-east corner of the Stubbs Street, Macaulay Road intersection, to ensure pedestrians waiting to cross are in a space protected from trucks that might mount the kerb, and that ramps and TGSi align to direct pedestrians with a vision impairment across the crossing appropriately.
3. Construct raised thresholds with appropriate TGSi across Bent, Eastwood and Bellair Streets at their intersection with Macaulay Road (south side).

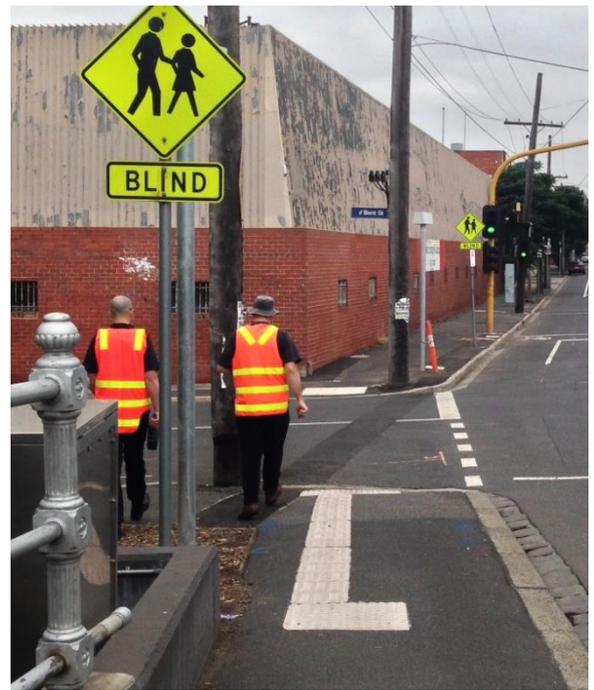
Compounding this issue, kerb ramps are not completely aligned.

Figure 15 – poorly aligned crossing at Bent Street

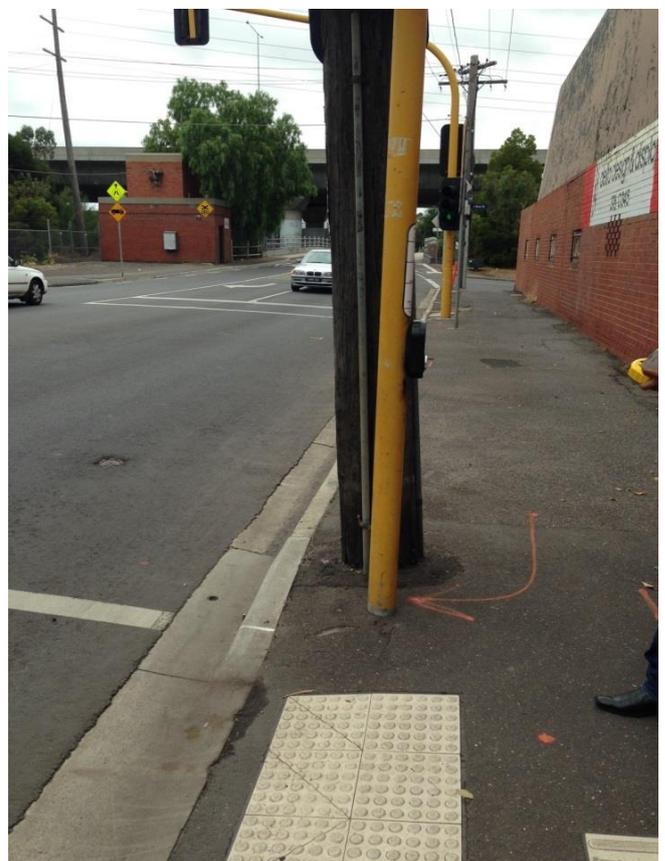
Figure 16 - pole obscuring view to the east at crossing of Macaulay Road, Stubbs Street

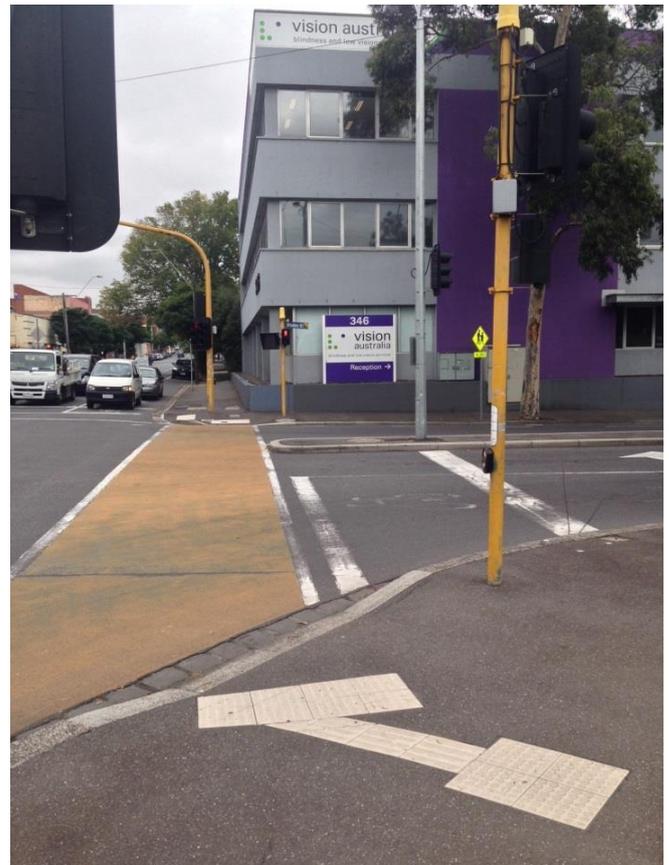
Vision Australia has an office at the intersection of Stubbs Street and Macaulay Road. A positive aspect of this intersection is the use of yellow colouring to highlight the pedestrian crossing (**point 2, figure 16**). A negative aspect is the poor alignment of TGSI, the crossing and the tram ramp. If a blind pedestrian follows the cue of the TGSI, they will walk down the edge of the crossing and potentially trip over or be confused by the raised median. If they follow the cue of the tram ramp they will walk into the middle of the intersection. The auditor suggested the pole on the south side of the intersection,

next to the Macaulay Road crossing, may obscure the view of traffic (**figure 17**).

Figure 17 – crossing of Stubbs Street from Macaulay Station to Vision Australia

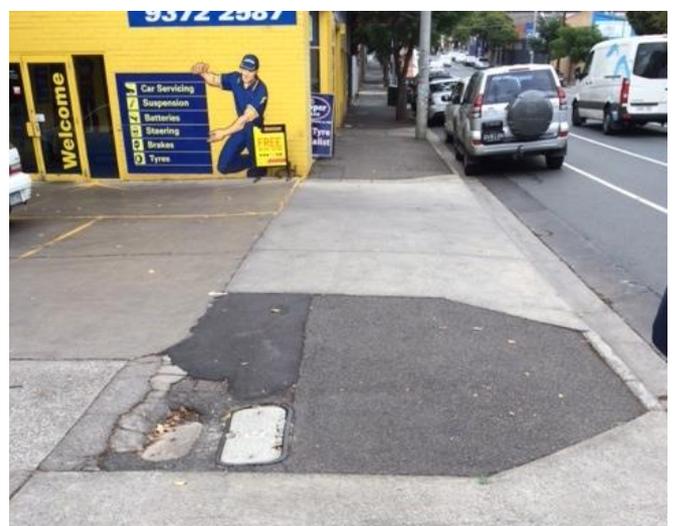
Figure 18 – footpath outside 425 Macaulay Road

4. Remake the footpath outside 425 Macaulay Road, in a manner that intuitively indicates pedestrian priority to drivers.
5. Construct a raised threshold with appropriate TGSi across Barnett Street at the intersection with Macaulay Road (north side).

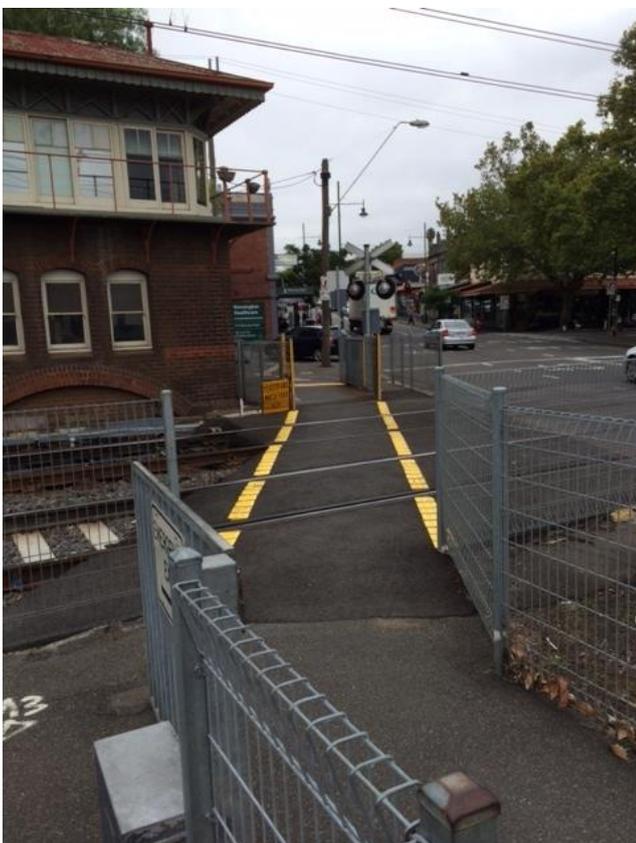
Figure 19 – pedestrian crossing of railway line, south side of Macaulay Road

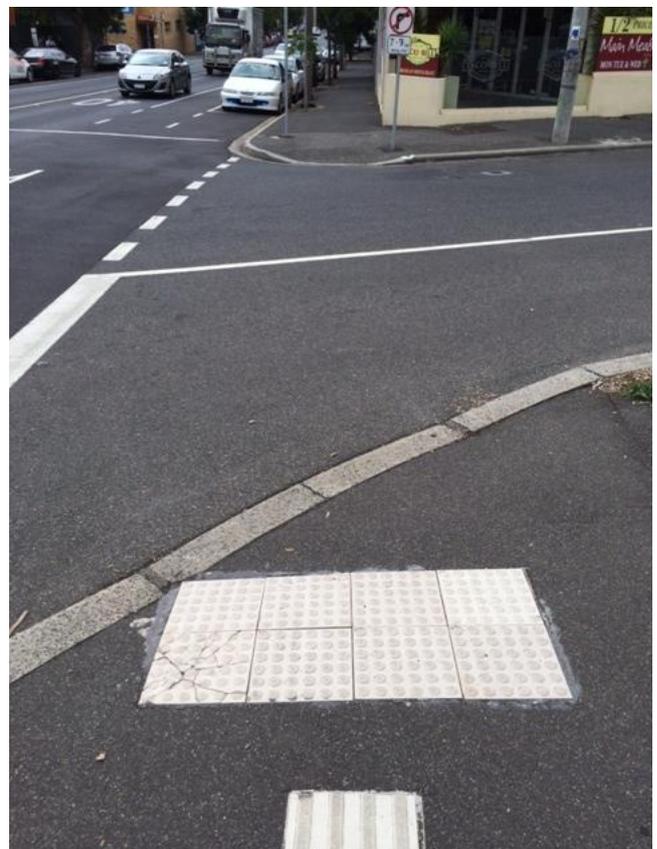
- Absence of TGSI at some crossing points.
- Audio tactiles on most crossing legs were not within arm's reach of a pedestrian waiting at the kerb ramp.

Figure 20 – Poorly configured ramp and absent TGSI (other side of the road) at Eastwood Street

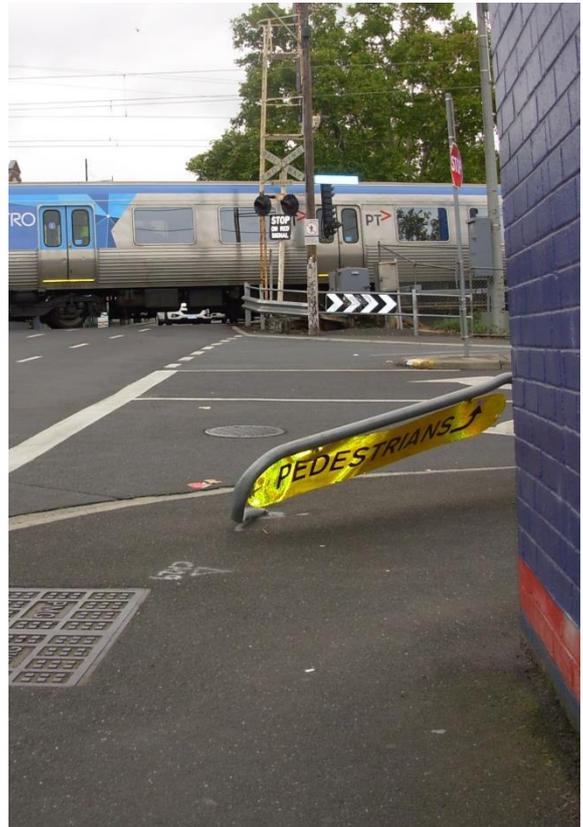
Figure 21 – damaged sign at Macaulay Road, Rankins Road, Eastwood Street

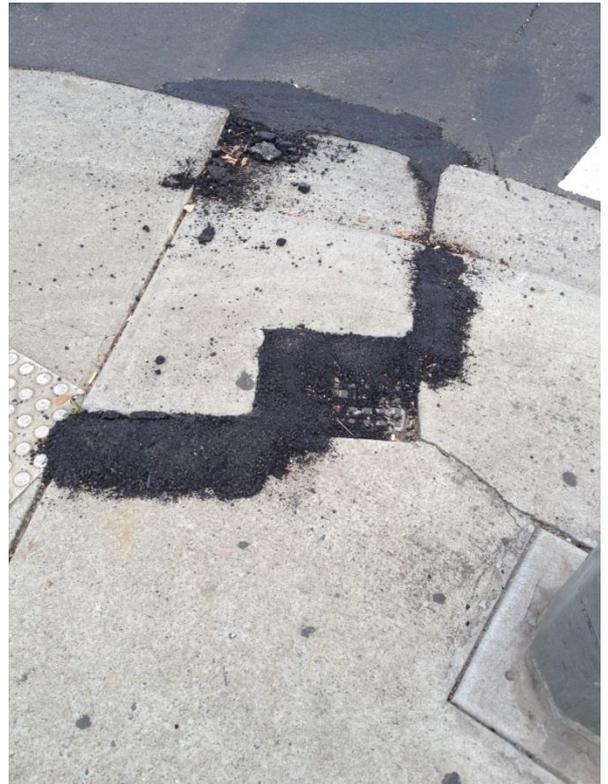
Figure 22 – poorly maintained footpath, corner Glenferrie and Toorak Roads

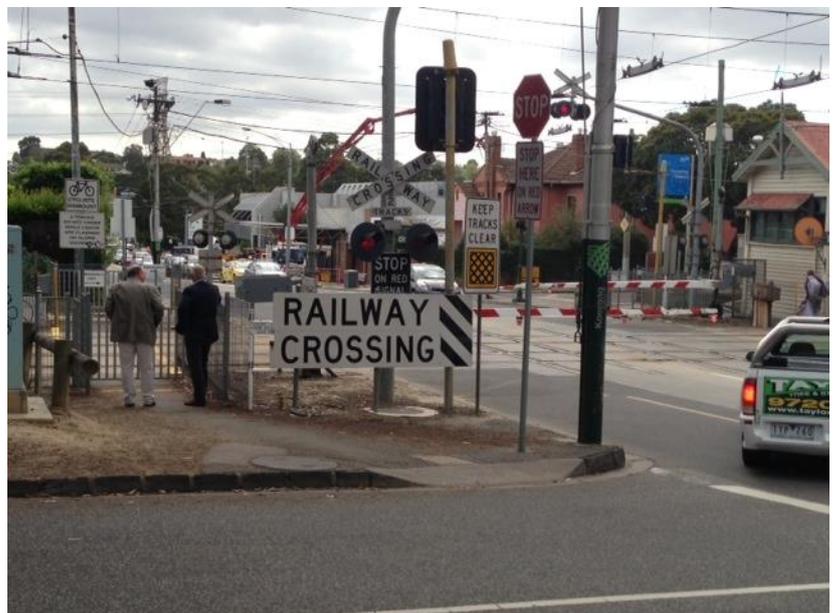
Figure 23 - poor alignment of road and railway crossings, Warra Street

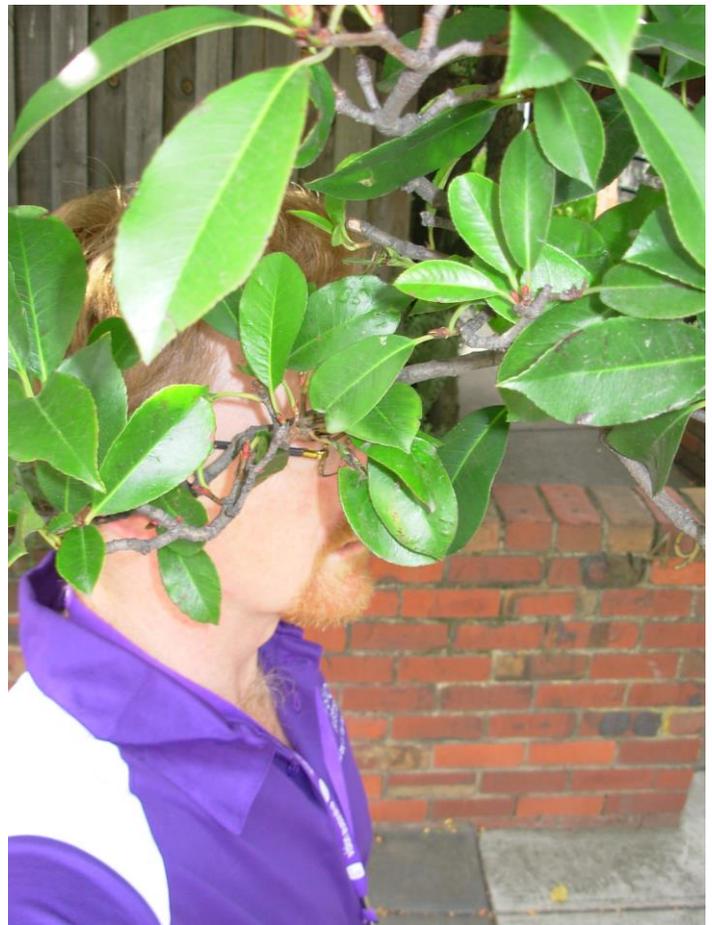
Figure 24 – overhanging branch, east side of Glenferrie Road, between Callantina and Riversdale Roads

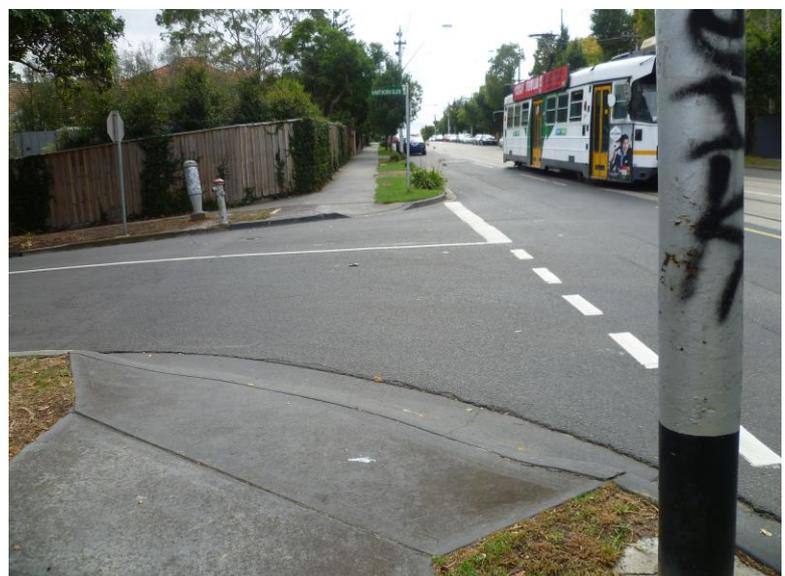
Figure 25 – poorly oriented kerb ramps, and corners that allow higher speed turning, Hawthorn Glen

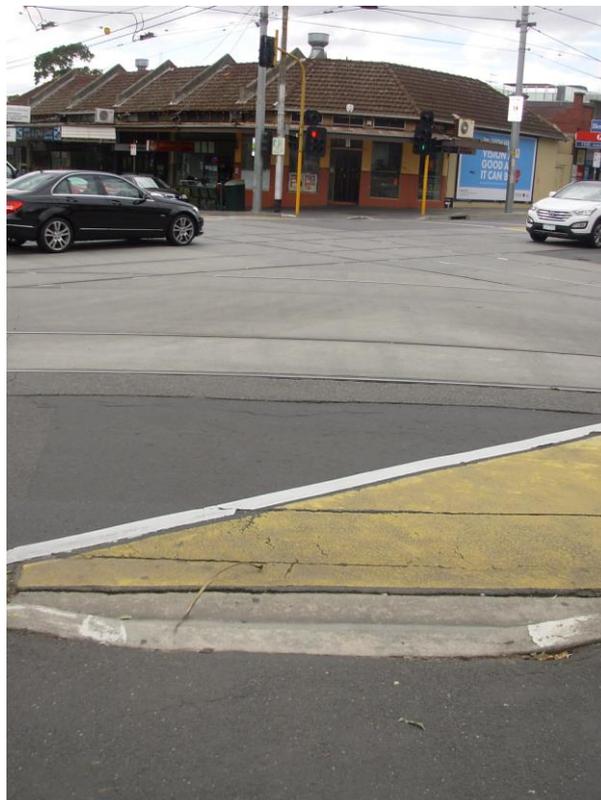
Figure 26 – kerb ramps oriented towards the centre of the intersection, rather than the direction of the crossing (highlighted in yellow), corner Riversdale and Glenferrie Roads
