## Appendix B – Bus stop access audits

Access audits were conducted for 70 bus stops in Victoria. Approximately half were conducted in person during June and July 2021. The rest were conducted as desktop audits using Google StreetView (street level, panoramic photos taken by Google and available in Google Maps [www.google.com.au/maps/](http://www.google.com.au/maps/)).

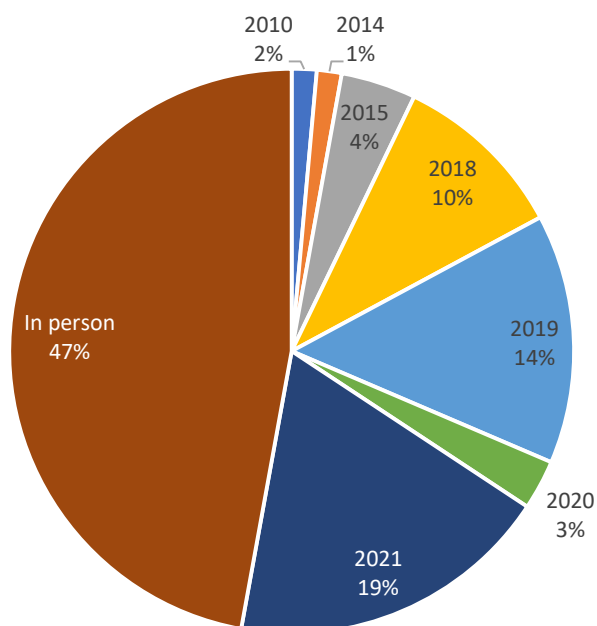
Figure B.2. Audit type and year of StreetView photos for desktop audits (70 stops). Just under half of the access audits were conducted in person and the majority of desktop audits were based on photos from the last couple of years.

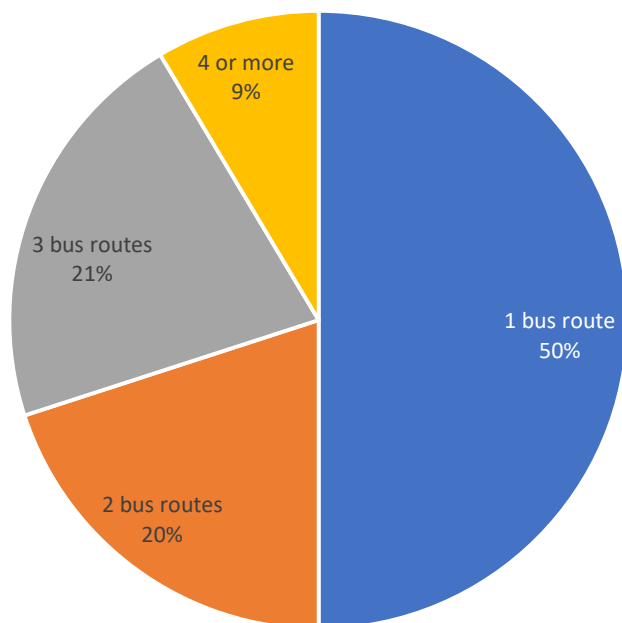
Figure B.3. How many bus routes use this stop? (70 stops) Half of stops were serviced by a single bus route.

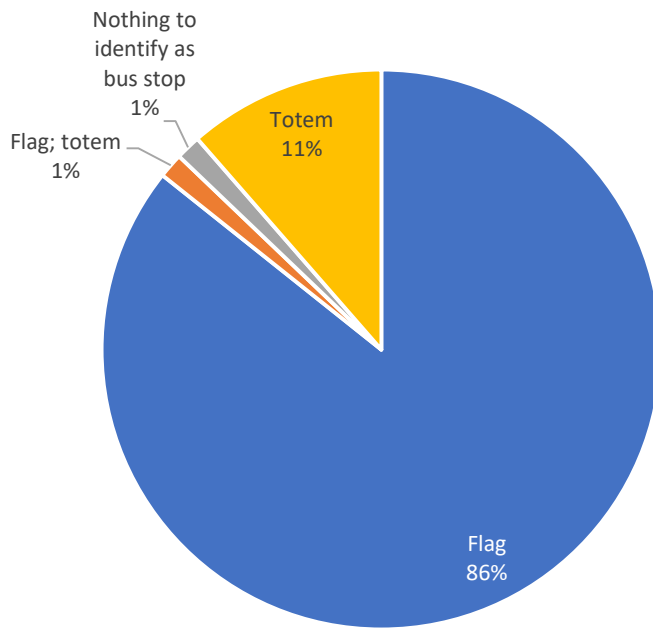
Figure B.4. How is the stop identified? (70 stops) All stops except one were identified by either a flag or totem.

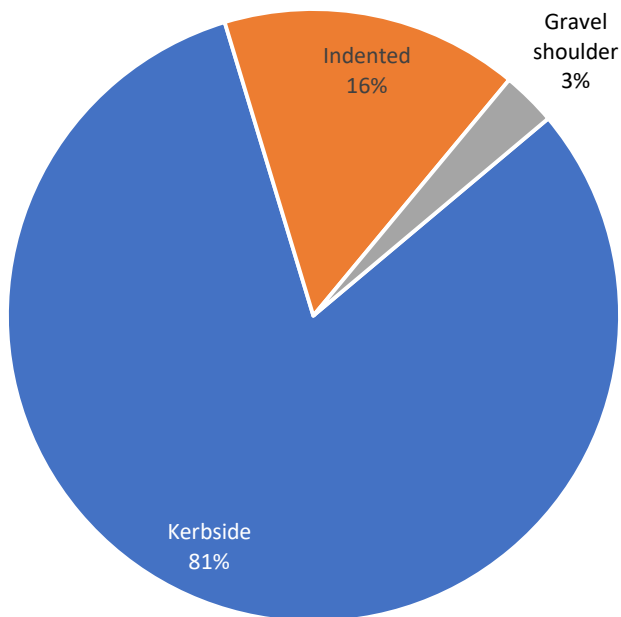
Figure B.5. What type of stop is it? (70 stops) Most stops were kerbside; part of the road.

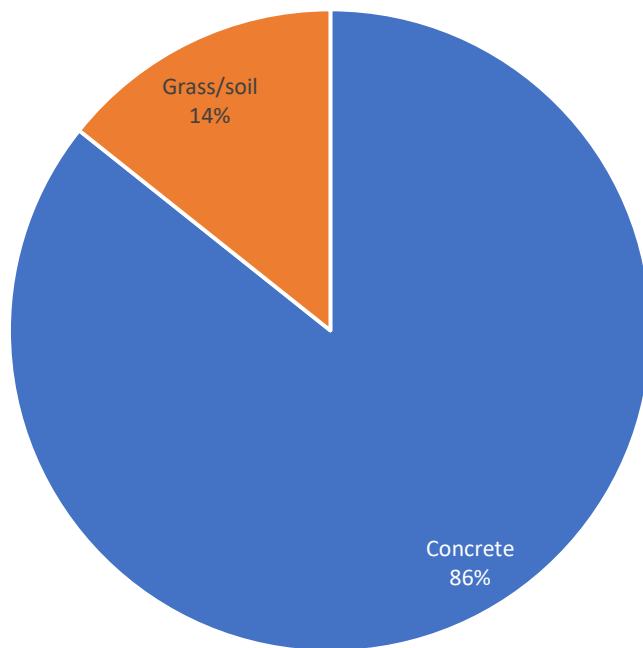
Figure B.6. What is the ground type? (70 stops) Most stops had a concrete base.

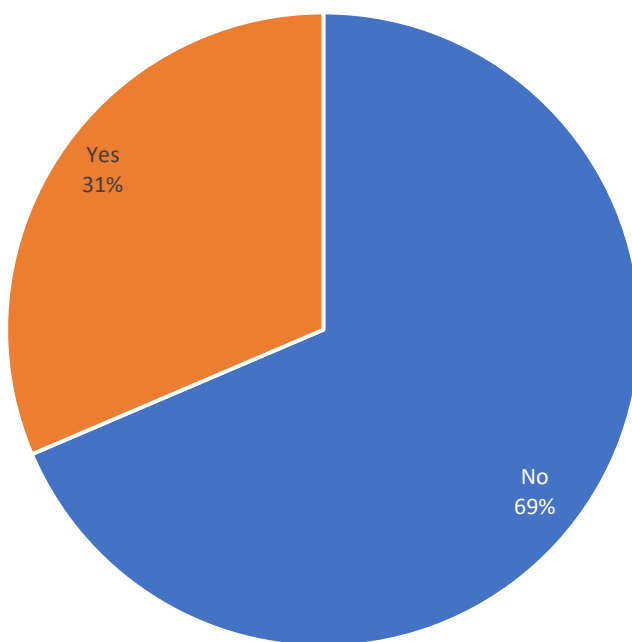
Figure B.7. Is a formal shelter provided? (70 stops) Only one third of stops had a formal shelter.

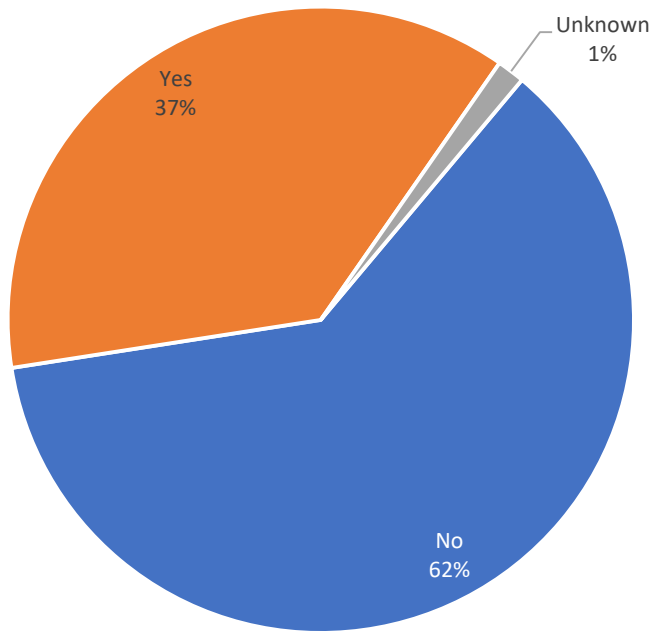
Figure B.8. Is formal seating provided? (70 stops) Formal seating is usually provided with formal shelters.

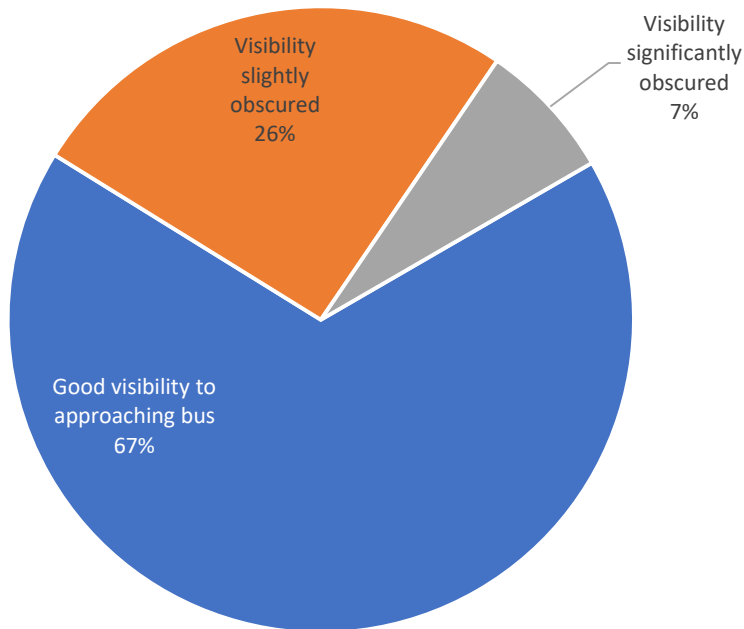
Figure B.9. How visible is an approaching bus while waiting? (70 stops) Most stops had good visibility to an approaching bus.

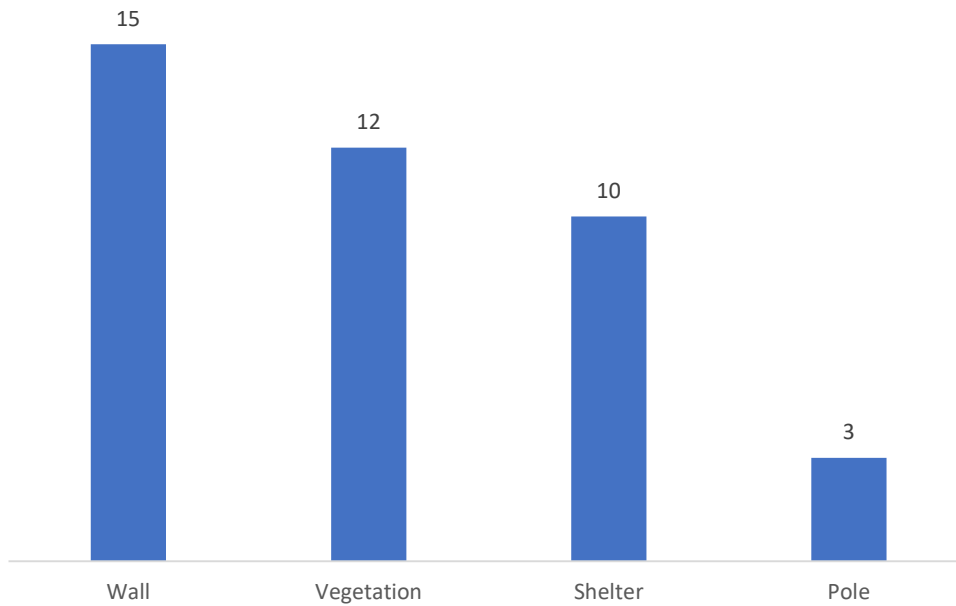
Figure B.10. What other obstructions limit visibility around the stop? (70 stops, multiple responses permitted). High property walls and vegetation, along with the shelter itself, can limit visibility.

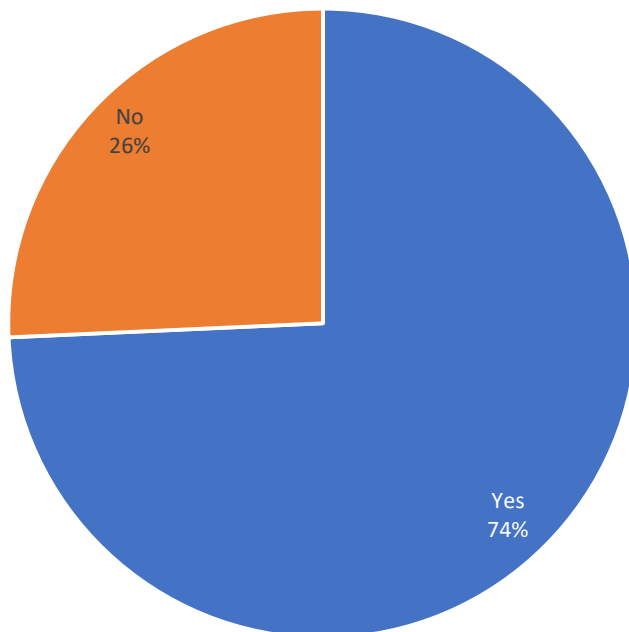
Figure B.11. Is there a streetlight at the stop? (70 stops) Three in four stops have a streetlight, but as the audits were conducted during the day it is not known if they were working or how well they light the stop.

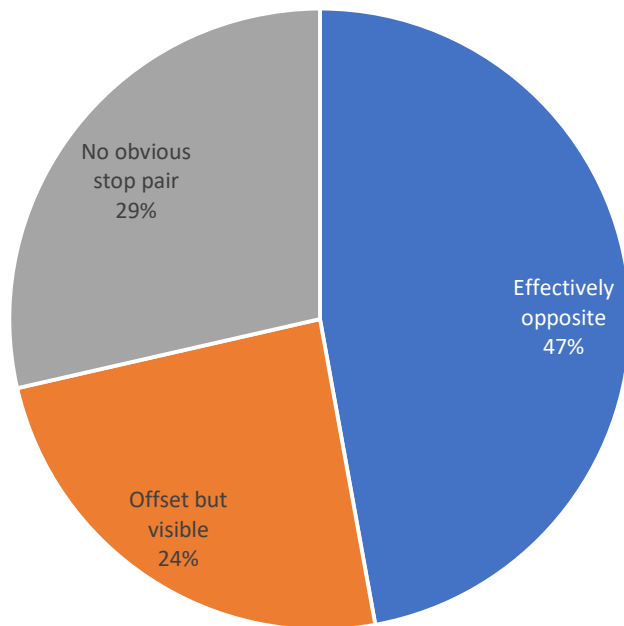
Figure B.12. Where is the bus stop pair? (70 stops) The bus stop for buses in the opposite direction was visible from about two-thirds of stops.

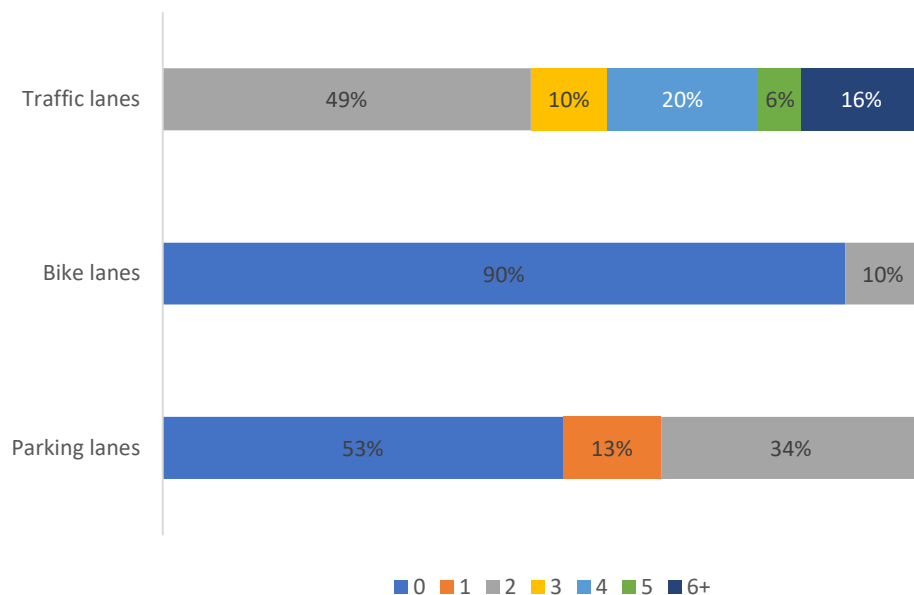
Figure B.13. How many marked or operating lanes are there? (70 stops) Half of stops were located on roads with three or more lanes of traffic.

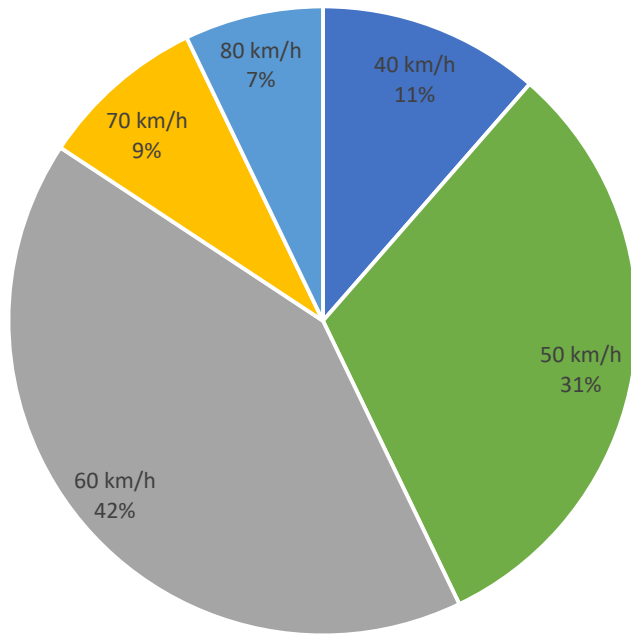
Figure B.14. What was the speed limit at the time of auditing? (70 stops) 89% of stops were on roads with a speed limit higher than the 30-40 km/h recommended for pedestrian safety and activity.

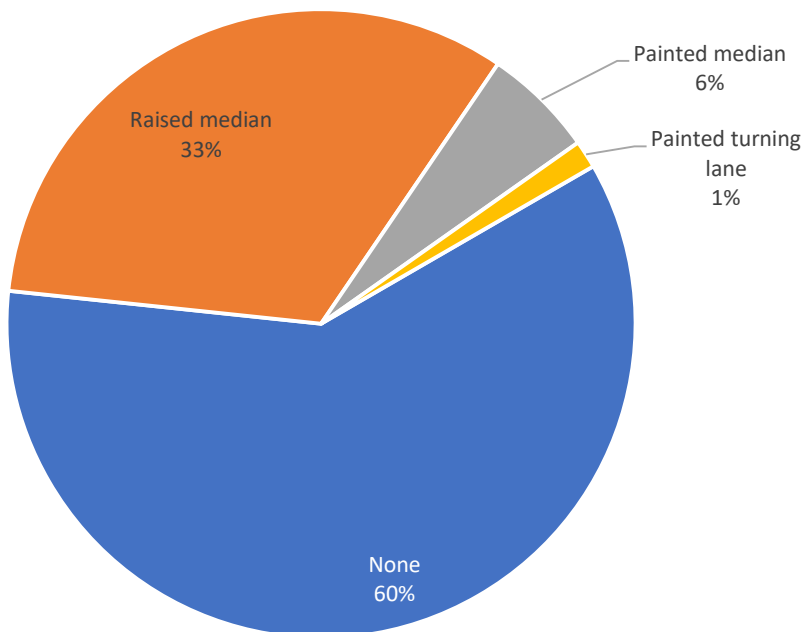
Figure B.15. What type of central median is there? (70 stops) There was no median of any description at 60% of sites.

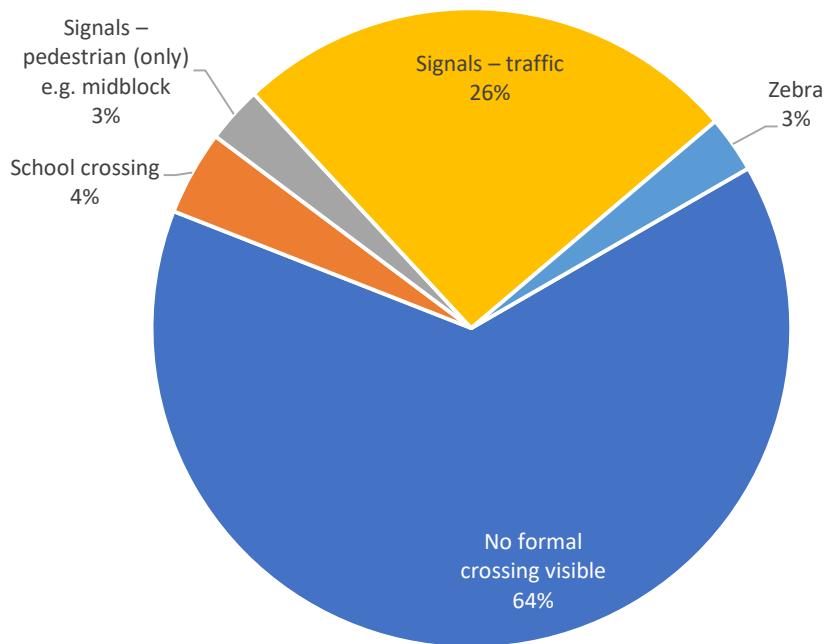
Figure B.16. What is the closest formal pedestrian crossing? (70 stops) There was no formal crossing visible from two-thirds of stops.

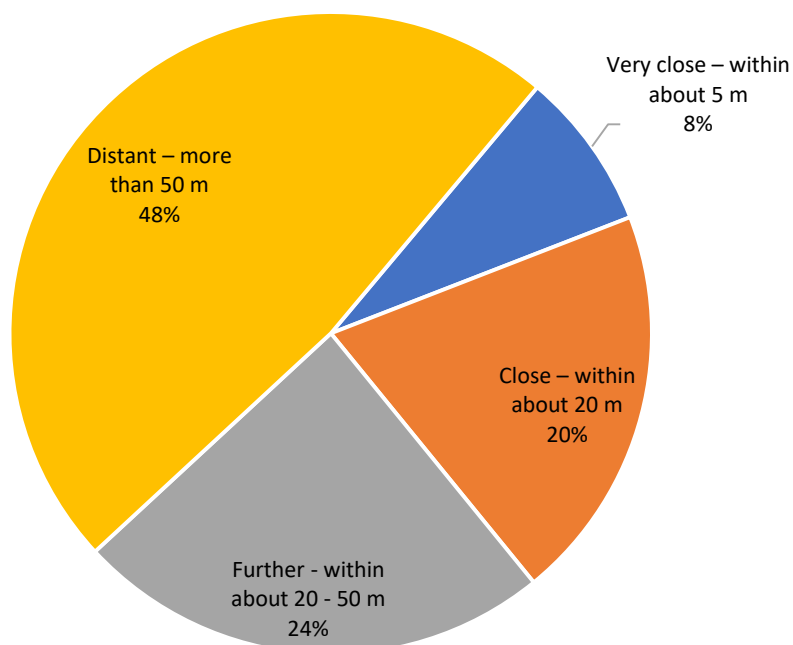
Figure B.17. Approx. how far is the crossing from the bus stop? (25 stops with formal crossing visible) About half of formal crossings visible from the stop were more than 50 m away.

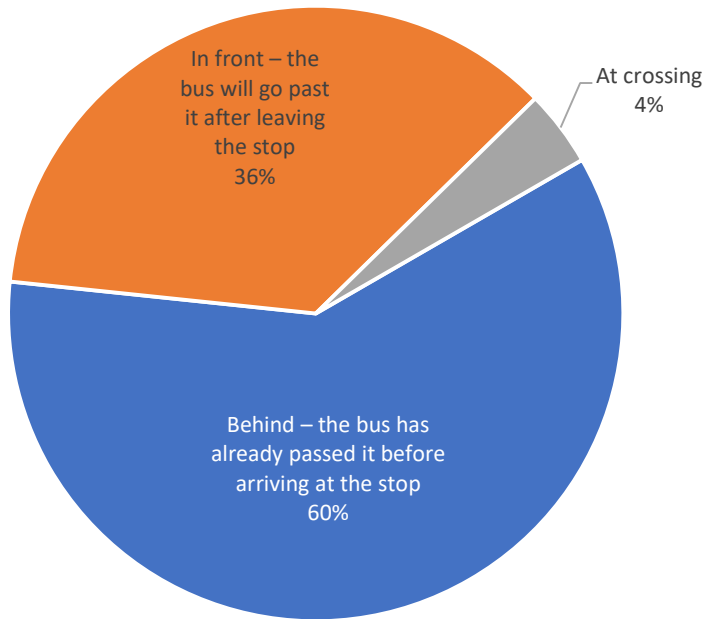
Figure B.18. Where is it in relation to the stop? (25 stops with formal crossing visible) Most formal crossings were located behind the bus stop, which is generally good for bus operations but bad for walking as it requires backtracking.

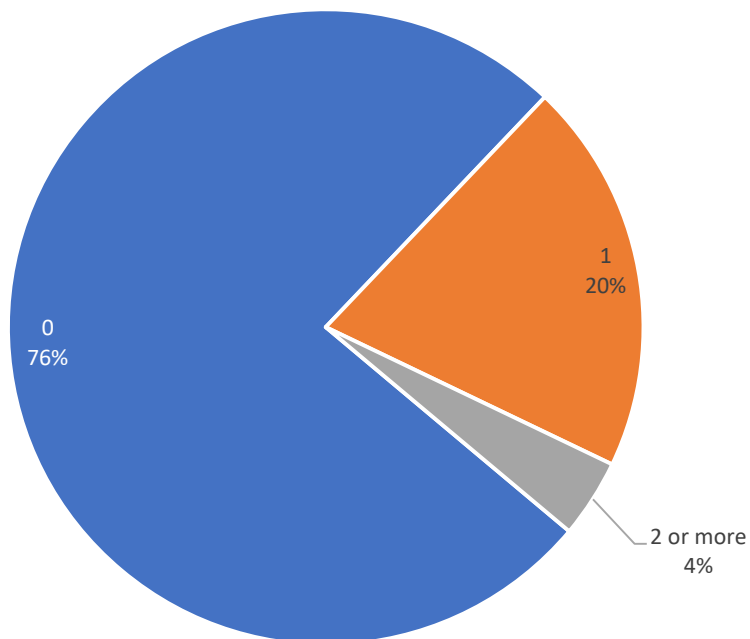
Figure B.19. How many side roads are between the bus stop and crossing? (25 stops with formal crossing visible) People would not have to cross a side road to get from the crossing to the bus stop at three in four locations.

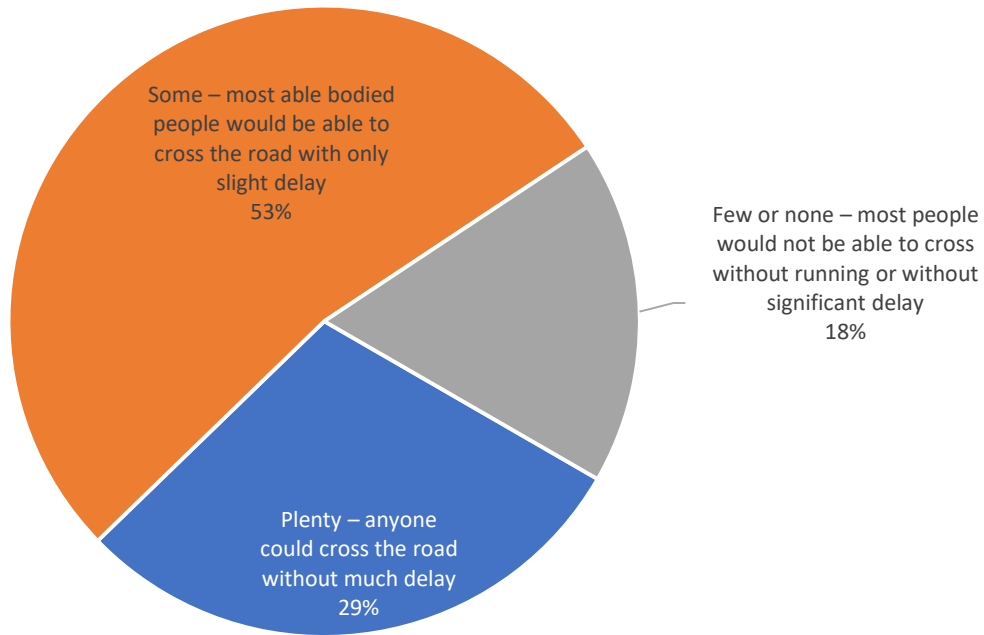
Figure B.20. How many breaks in the traffic are there if someone wants to cross the road? (17 stops with no formal crossing visible and audited in person) Nearly one in five roads with no formal crossing did not have breaks in the traffic which would allow people to cross without running or being significantly delayed.

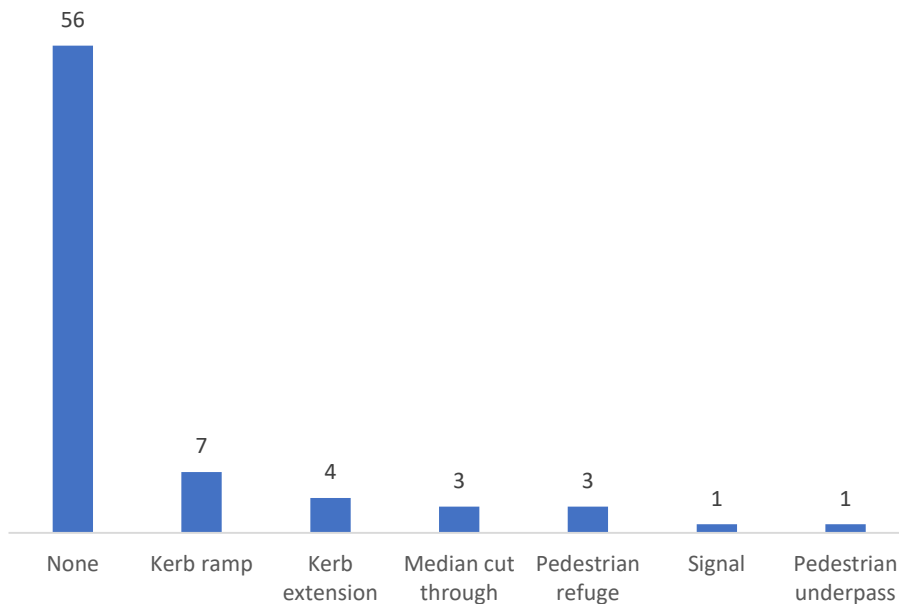
Figure B.21. What other crossing assistance is provided specifically for people walking? (70 stops, multiple responses permitted) Most stops did not have any other form of crossing assistance.

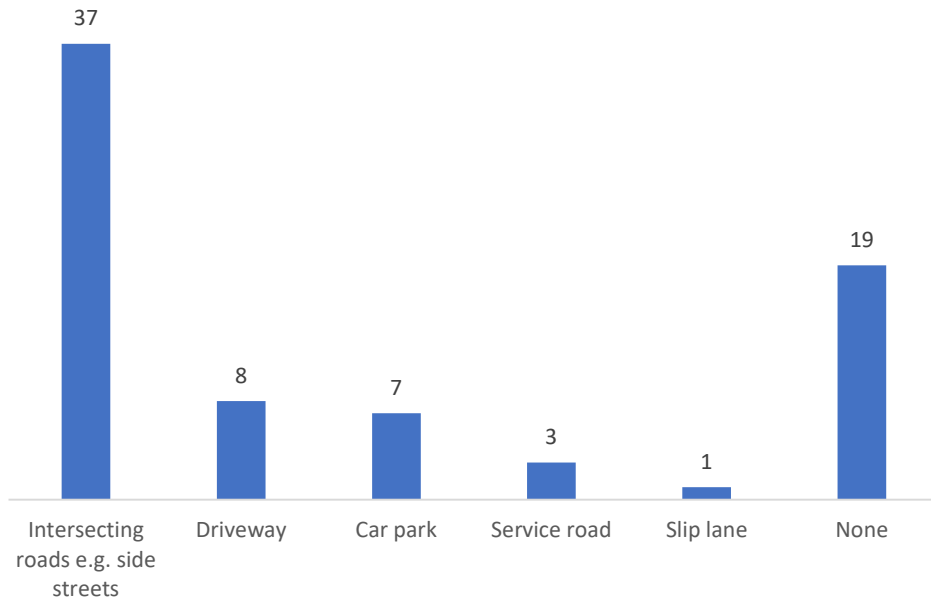
Figure B.22. What other significant vehicle paths are within approx. 50 m? (70 stops, multiple responses permitted) Half of stops had an intersecting road nearby.

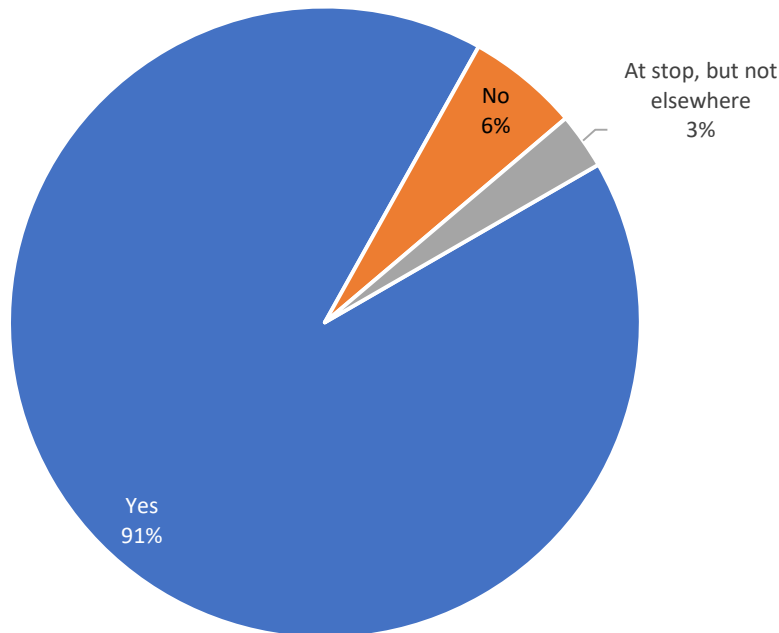
Figure B.23. Is there a kerb? (70 stops) There was a kerb at nearly all of the audited stops.

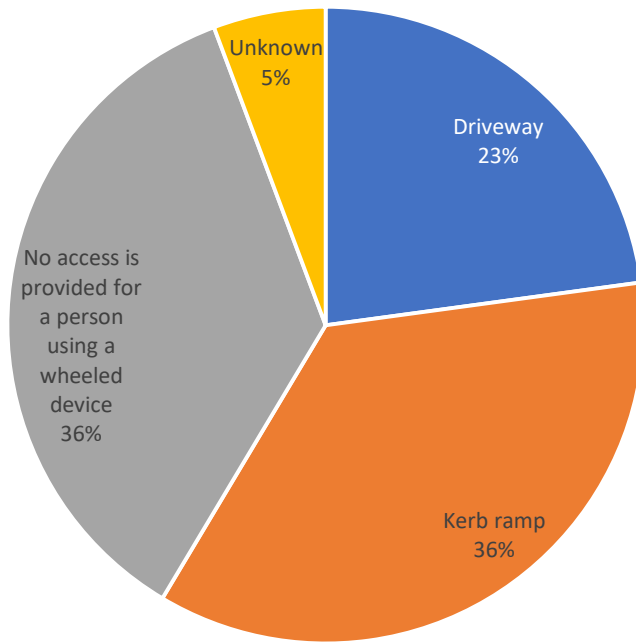
Figure B.24. When crossing from the opposite side of the road, how would a person using a wheeled device (e.g. wheelchair) access the bus stop? This may be at a nearby crossing rather than at the bus stop itself. (70 stops) One-third of stops did not have any access for people using wheeled devices.

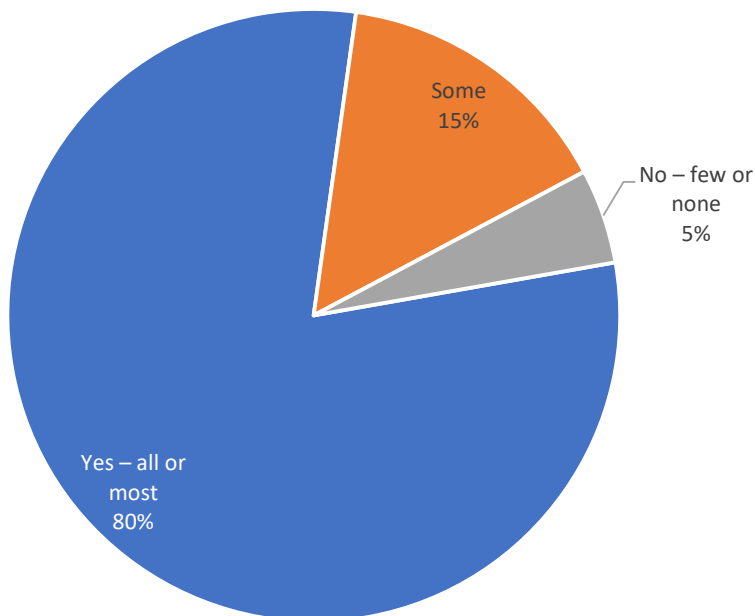
Figure B.25. Do kerb ramps near the bus stop generally appear to be DDA compliant? (20 stops) Most kerb ramps at stops appear to have a smooth transition, have splayed sides and perpendicular to the road.

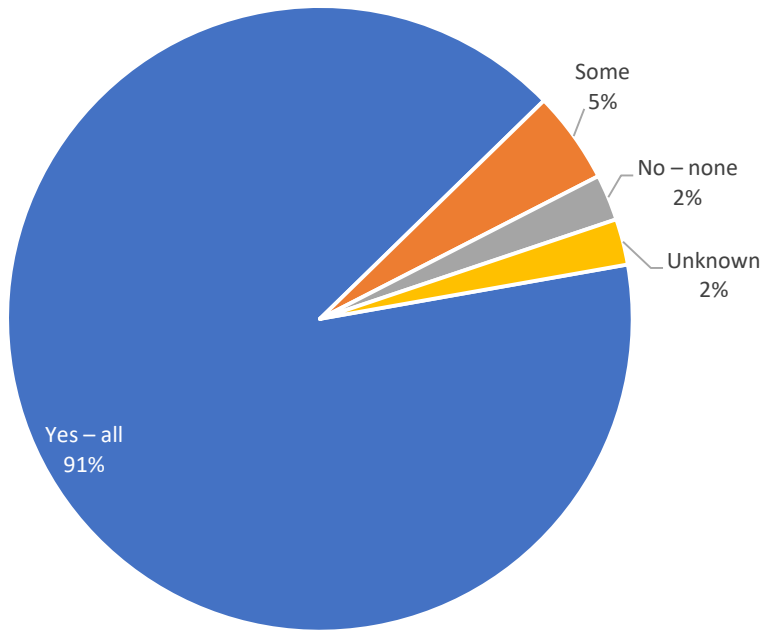
Figure B.26. Are kerb ramps provided to cross nearby side streets? (42 stops, others either didn't have kerbs at all or side streets nearby) Kerb ramps are provided at most side streets near bus stops.

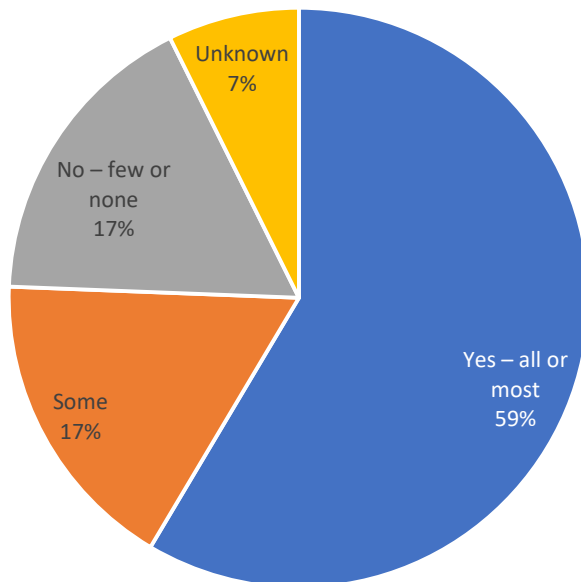
Figure B.27. Do kerb ramps at nearby side streets generally appear to be DDA compliant? (41 stops) More than half of kerb ramps at side streets appear to have a smooth transition, have splayed sides and be perpendicular to the road, however nearly one in five could be obviously improved.

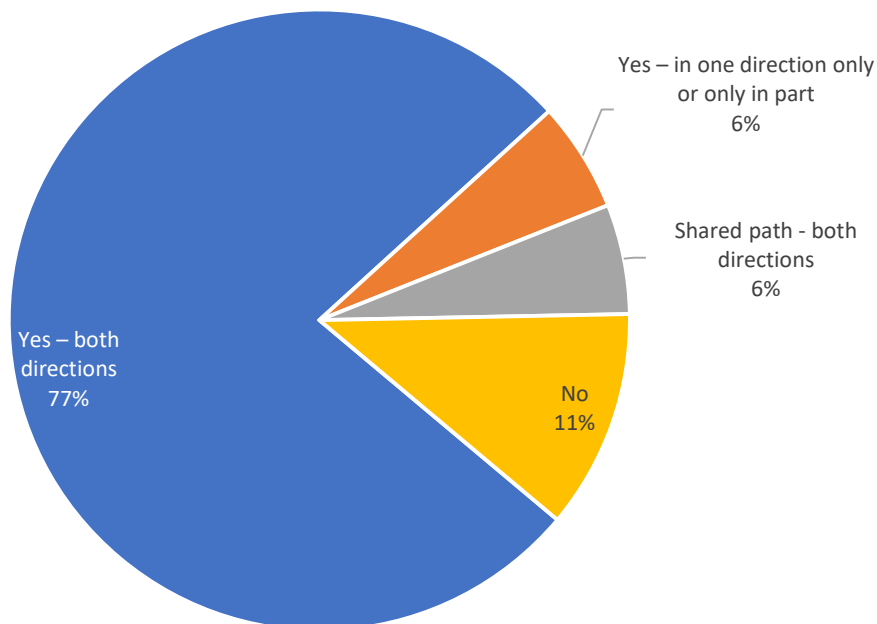
Figure B.28. Is there a footpath connecting to the bus stop? (70 stops) Most stops have a connecting footpath, although one in ten don't have any sort of path connection.

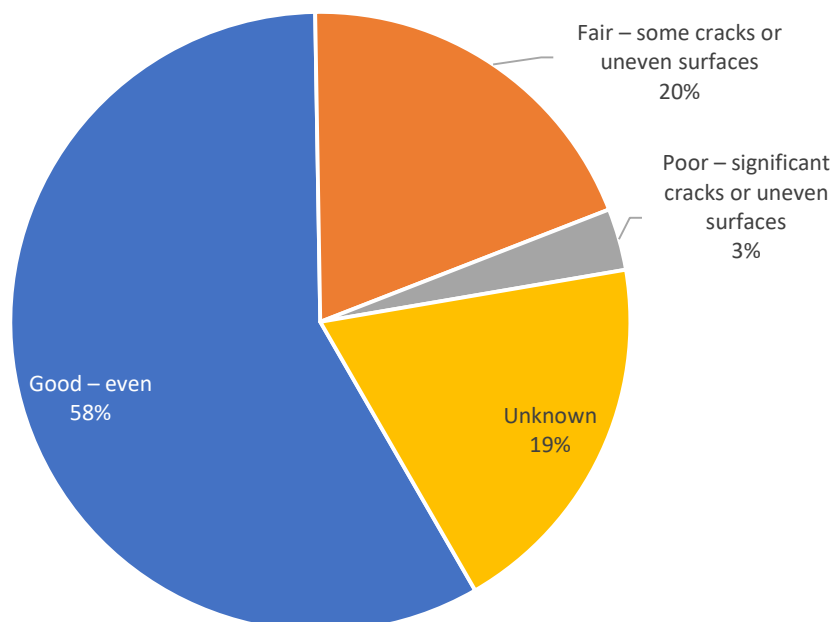
Figure B.29. What is the general condition of the footpath? (62 stops) The condition of the paths was generally good, with smooth, even surfaces; noting that the condition couldn't be determined in some desktop audits.

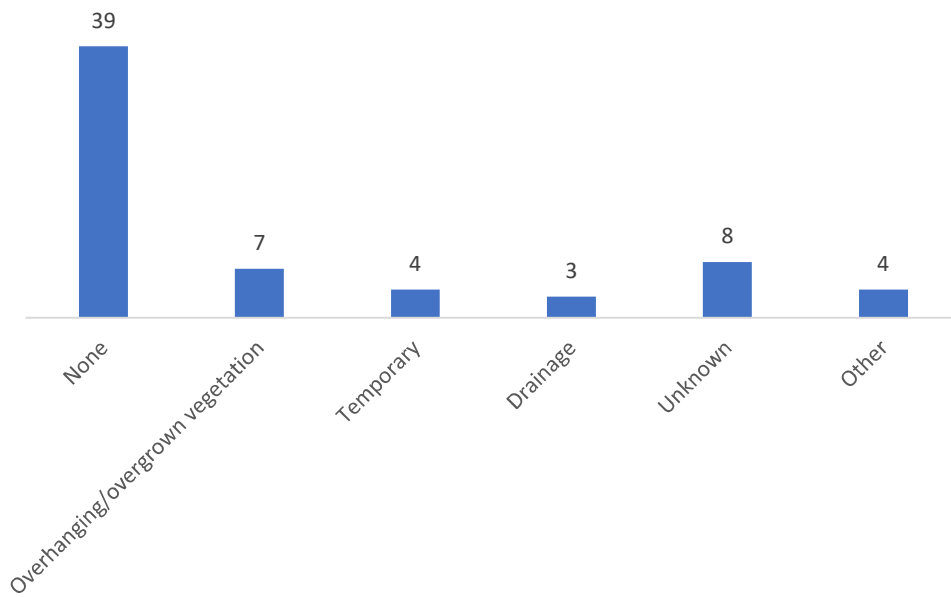
Figure B.30. What obstacles are on or along the path? (62 stops, multiple responses permitted) Paths were generally free of obstacles.

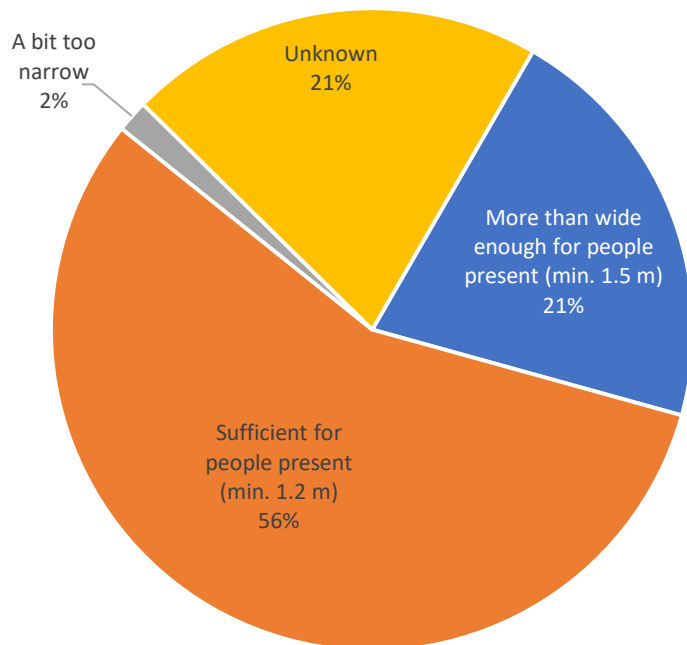
Figure B.31. How well does the footpath generally accommodate people using it? (62 stops) The majority of paths appeared sufficiently wide for the people present, although there were often not large numbers of people present (see Figure B.33).

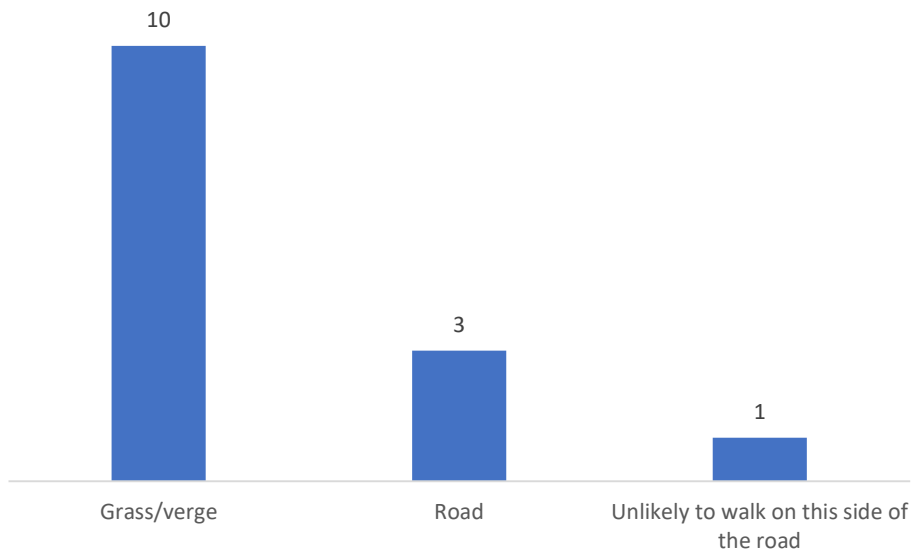
Figure B.32. In sections where there is no footpath, where would people walk? (8 stops, multiple responses permitted) At most stops where there was no footpath there was a verge or grassed area people could walk, assuming they are able to walk on this surface.

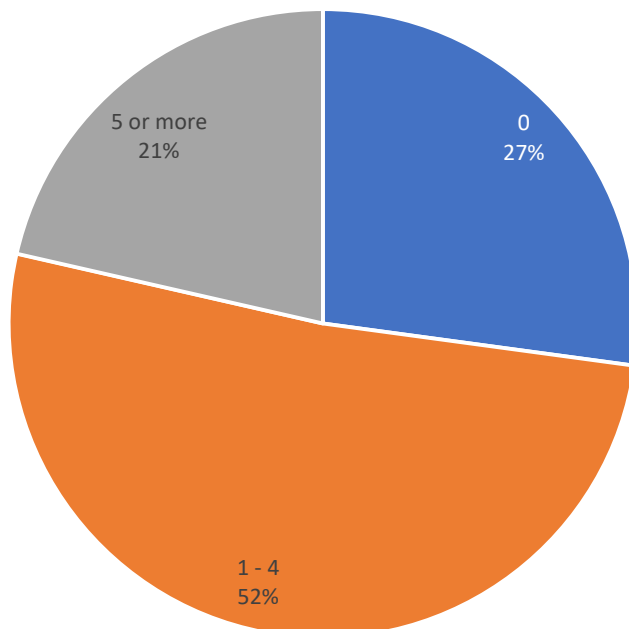
Figure B.33. How many other people were nearby while auditing the bus stop? (70 stops) This includes only people out in public space or adjacent areas (e.g. garden, outdoor dining), not people in vehicles or buildings. There was at least one other person around at most stops, including people waiting for the bus. However, at one in four stops there was no one else present. Note that all of the audits were conducted during the day and that fewer people would be expected at night.

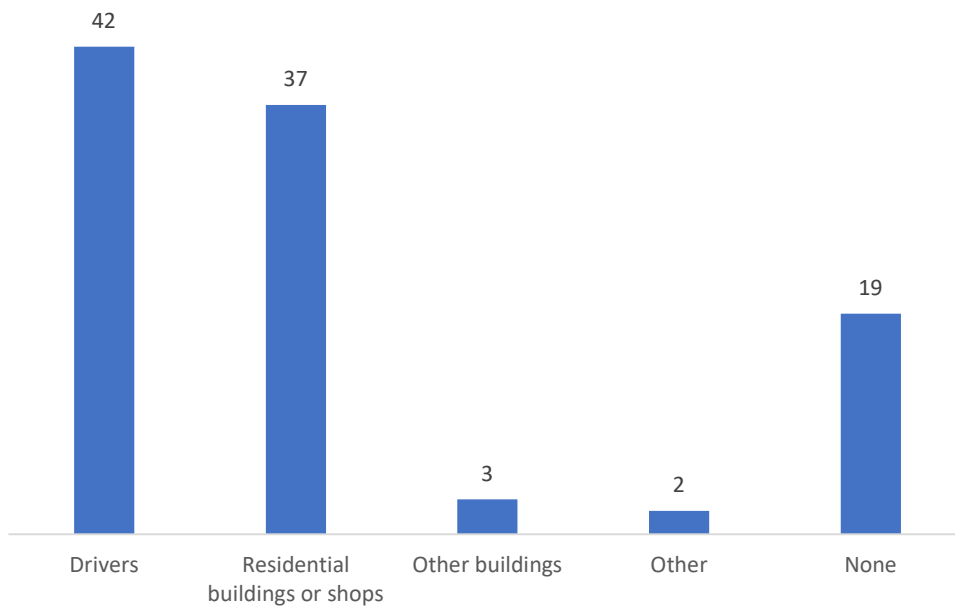
Figure B.34. What other passive surveillance is there? (70 stops, multiple responses permitted) Drivers and residential buildings or shops commonly provide passive surveillance. Drivers at high speeds might be travelling too fast to observe or stop and assist. Less than half of stops had reasonable passive surveillance from neighbouring buildings.

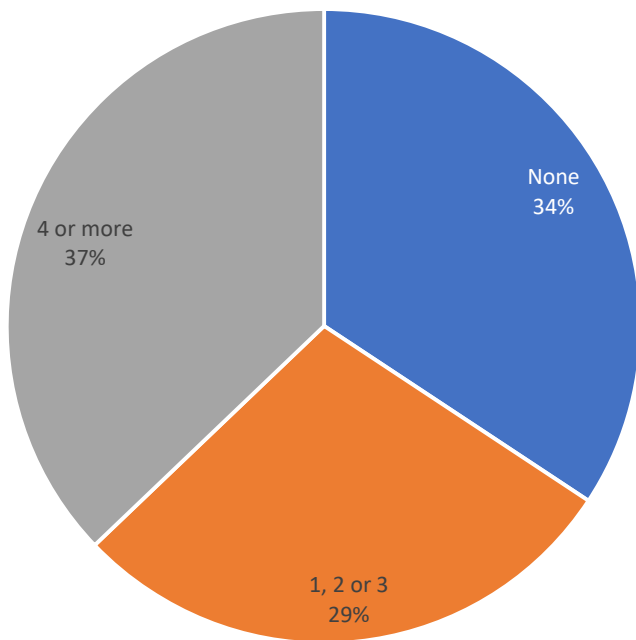
Figure B.35. How many trees provide shade for people walking to the bus stop? (70 stops, multiple responses permitted) Includes only trees large enough to stand under, on public land (those in private properties are often outside the control of authorities) and within 50 metres of the bus stop. Two thirds of stops had shade trees nearby. Encouragingly, many of the stops recorded with few or no shade trees did have other trees nearby but they were in the median, on the opposite side of the road, within private property or were new saplings which hadn't yet grown to maturity.
